An assessment of Cikangkareng rockfall due to the Tasikmalaya earthquake on September 2, 2009

Lestari Sri Anastasia^{1,*} and Lim Aswin¹

¹Civil Engineering Department, Parahyangan Catholic University, Jl. Ciumbuleuit 94, Bandung, Indonesia

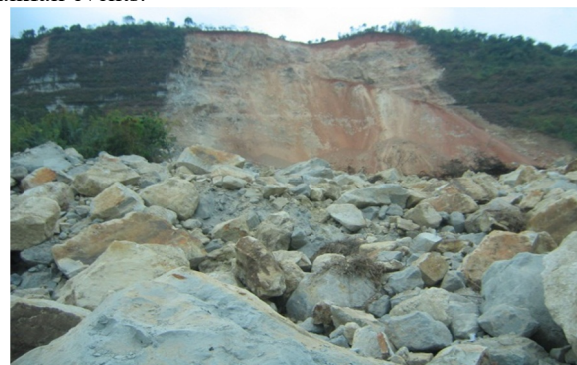
Fig. 1. Debris materials consisting of large rocks (private document)

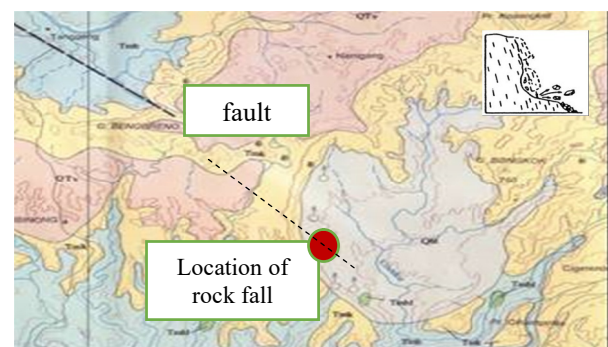
As shown in Fig. 5, the disaster area is composed of Koloberes (Tmk) rock formation, which is composed of sedimentary rocks with sand, crystal tuff, breccias with a parallel coating and is less massive. The rocks have been clogged with the weathering soil, such as silt and clay, and the color is brownish or reddish-brown. In addition, due to the long drought, the crack is also observed on the ground.

Based on the Cianjur Area Vulnerability Zone Map [7], the disaster area is located in a high potential ground movement zone. This means that the land movement is easily triggered by high rainfall or earthquake. With the earthquake magnitude of 7.3 SR, the sedimentary rocks clogged with the weathering collapsed and the material slid into the residential area.

Fig. 5. Regional geology of rockfall area [6]

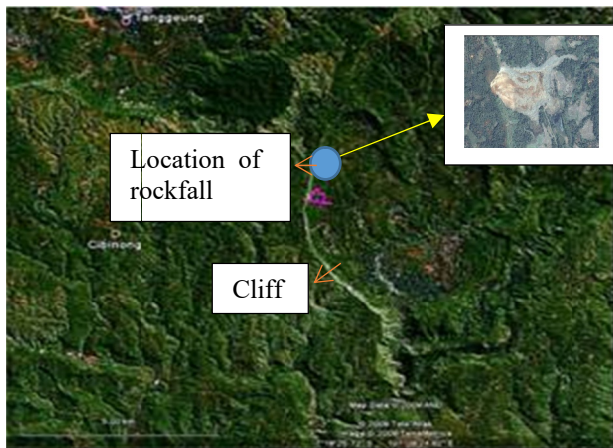
Fig. 6. Satellite image of rockfall area (Google Earth)

The large areas under the crown of old rockfall and the landslide were triggered by heavy rainfall.

The topography at the disaster site has a slope with an inclination of almost 80° -90°. Below the cliff, there is Babakan Caringin village whose ground inclination is around 5°-15°. (Figs. 6 and 7). Land movement disasters at Cikangkareng are categorized as rockfall. Some debris material has also been found in this event (Fig. 8). A large earthquake force in the horizontal and vertical direction causes an increase of porewater pressure and inside the fractured rock. As a consequence, the friction resistance in the joint plane is significantly reduced. It should be noted that the stability of rock slopes is influenced by several factors such as joint orientation, joint roughness, width and spacing of joint, fill material in the joints, and the existence of water.

- It is recommended that all areas under the crown of old rockfall and should be sterilized from human settlement, the risk is still high.

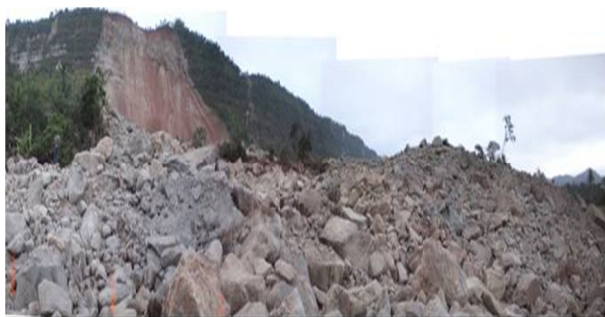
Fig. 7. The rockfall at Cikangkareng

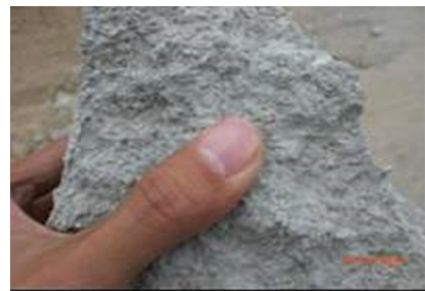
Based on the field observation, the debris material was dominated by rocks mixed with soil. The type of rock is grey colored sandstone (Fig. 9) and many fracture joint (Fig.10).

Fig. 9. Soft grey sandstone

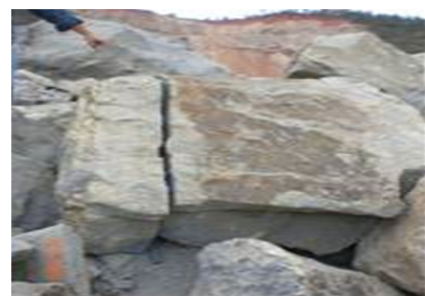
Fig. 10. Fracture joint

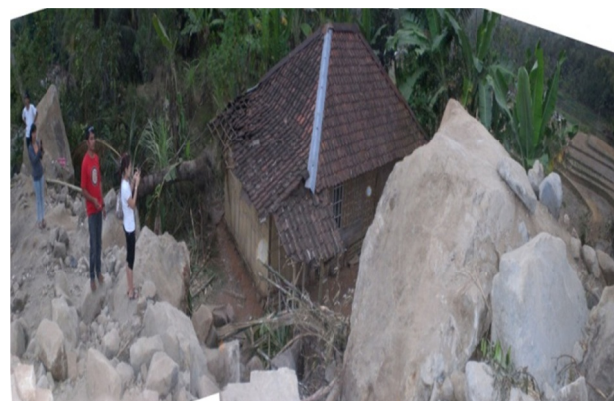
The size of debris was like very large weathered rockfall. Fig. 11 shows the size of rockfall debris compared to the size of the village house and Fig. 12 shows the variable size of the rocks. Fig. 13 shows the type of jointed and fracture rock at the crown of the rockfall.

Fig. 11. The size of rockfall debris

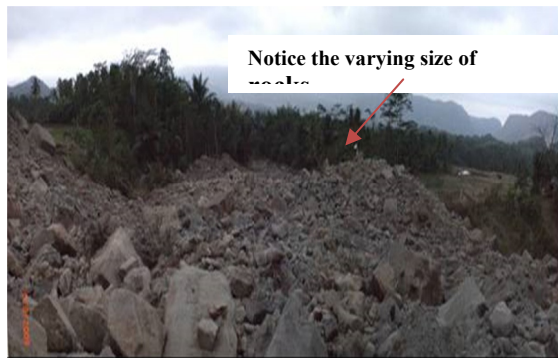
Fig. 12. Rockfall debris (Rahardjo 6 Sept 09)

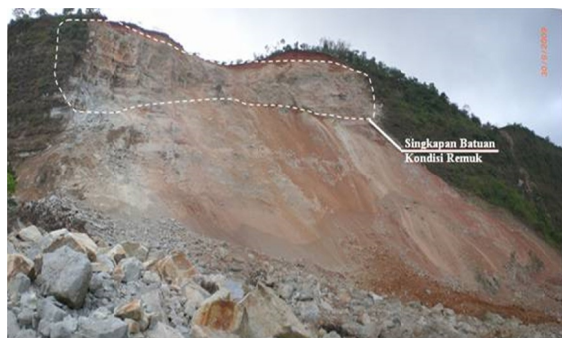
Fig. 13 Jointed rock and fractured rock exposed at the crown of rockfall

- The Rock condition at the site is fractured, jointed and soft, there is an indication of old rockslides in a wider area. Moreover, there is the possibility of fault reactivation due to the earthquake.

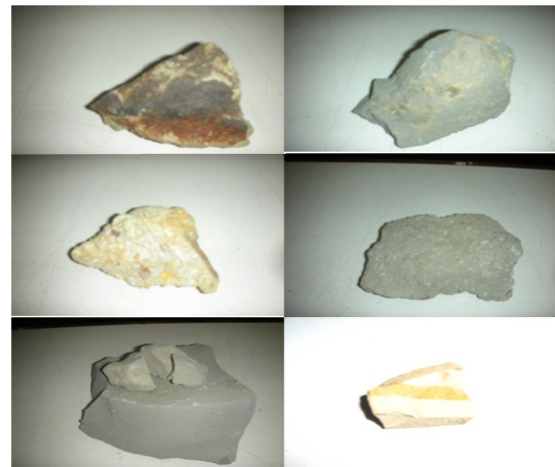
The debris rockfall due to the chemical weathering process (Figs. 14 and 15). The chemical test shows that the composition of the chemical is SiO_2 ($\pm 59\%$), and Al_2O_3 ($\pm 14\%$) Fe_2O_3 (6 -8%), CaO ($\pm 4\%$), LOI ($\pm 6\%$).

Fig. 14. Many colors of Cikangkareng Debris

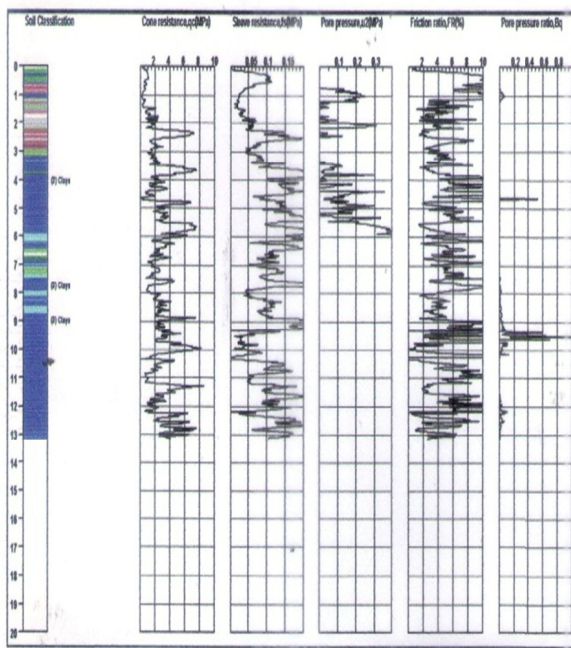
The Piezocone test was conducted at the toe of the debris to investigate the soil condition and debris thickness. But due to the limitation of penetration, it was only carried out at one point. The Piezocone test consists of a biconus, a pore stone, water seals, sounding rods and reading tools. The purpose of the Piezocone (CPTU) test is to identify soil stratification and in-situ pore water pressure. The location CPTU-01 is at Cikangkareng. According to CPTU-01 the test results in Fig.16, a fine-grained was found sensitive soil of about 3.2 m in thickness. It indicates that this layer is landslide material. The clay layer with medium to stiff consistency was found at GL -3.2 m up to the end of testing (GL -13.0 m).

Fig. 16. Piezocone result test

- According to CPTu-01, a mixed sand and fine-grained soil were found consisting to approximately with 3.2 m in thickness. This indicates that this layer is a landslide material. A clay layer with medium to stiff consistency was found at GL -3.2 m to the end of testing (GL -13.0 m).

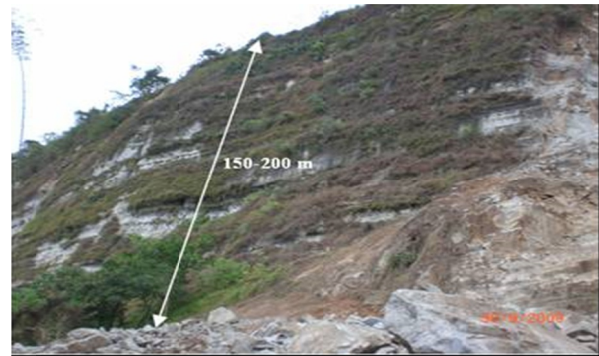
If the average thickness of the landslide was 10 m, then it could be estimated that the volume of debris was about 1 million m^3 . From Figs. 17 - 19, it was observed that the volume of debris material at Cikangkareng rockfall was close to the other events.

Fig. 17. Measurement of the height of cliff using GPS and rockfall distance of approximately 1.7 km

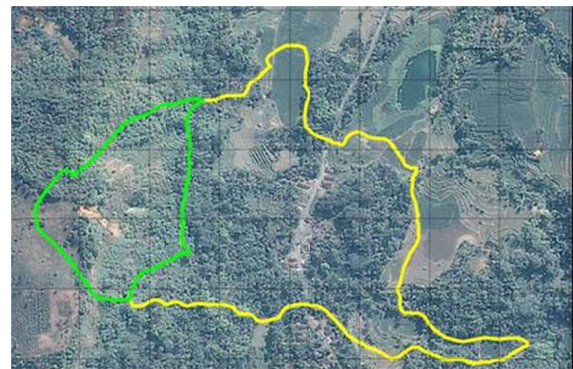
Fig. 18. Satellite image before the earthquake

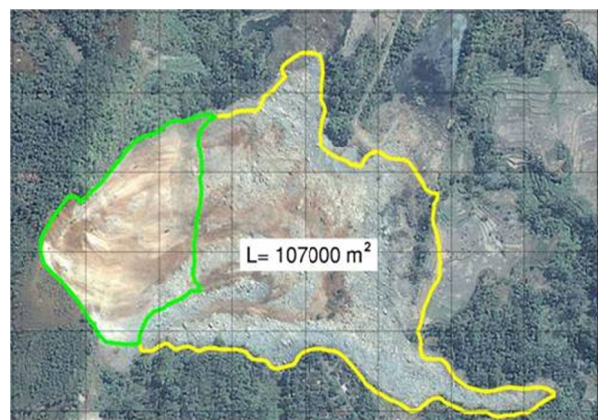
Fig. 19. Satellite image after the earthquake
