**INTERNATIONAL CONFERENCE ON DISASTER MANAGEMENT 2018  
(ICDM 2018)**

# LESSON LEARNED FROM RETAINING WALL FAILURES: A GEOTECHNICAL DISASTER

**Abstract**— This article presents five failure cases of retaining wall which are obtained from literatures and some personal documentations. One case is located in Singapore, two cases are located in Taiwan, and other two cases are located in Indonesia. Among those five cases, four cases were the unloading problems and one case was the loading problems. The objective of this article is to summarize the causes for those failures, according to the literature study and to provide some recommendations to prevent similar events happened in the future. The failure of retaining wall is categorized as a geotechnical disaster because it is not only causing major economic losses but also some casualties also been reported. The main reason for the failure was the improper design of the retaining and supporting system. One of the good indication before failure would occur was excessive movements induced by excavation or fill. Hence, it was recommended to install a proper geotechnical instrumentation in the construction and the nearby area. Moreover,

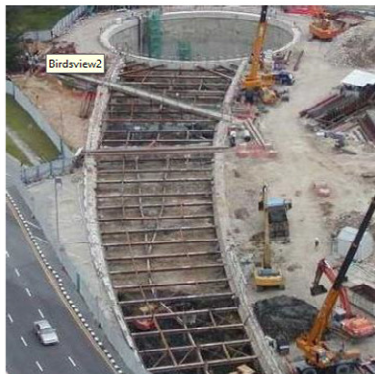
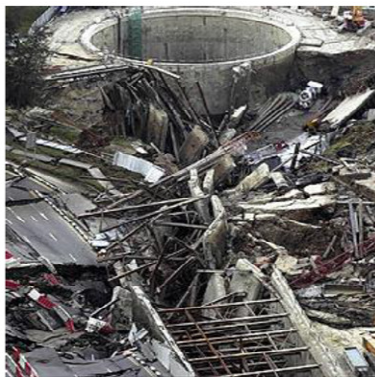
Fig. 1 Photo of Nicoll Highway excavation. (a). Before collapse, (b). After collapse. [12]

According to the Committee of Inquiry report, the failure did not develop suddenly. There were many warnings of approaching collapse but most of the warnings were either not taken seriously or ignored. Some of the events that occurred before the collapse shed some light on the critical error in the design methodology that is the use of effective stress approach (Undrained A) for the design of the diaphragm walls of the temporary retaining wall systems. Before the main failure occurred, excessive ground surface settlement in order of 400 mm has been detected. Vertical cracks of diaphragm wall panel also clearly observed. This crack was one of indication that the diaphragm wall has reached its capacity. For this reason, the jet-grouted piles were constructed in order to limit the wall deflections. On the day of the main event, the workers at the site heard sounds from the multi-level strut system at around 8 a.m. These sounds were investigated by the senior engineers of the contractor and unfortunately, they found that a lot of the waler-strut connections had undergone yielding. Then, immediate action was executed by evacuating all of the construction workers. In the afternoon, engineers from the owner's side came at the site and along with the contractor's engineers,

they decided to pour concrete at the 9th level of the strut for stabilizing the excavation. However, by 3:30 p.m the temporary system failed and causing 4 casualties and 3 people injured.

Official reasons for this collapse are reported by Committee of Inquiry, Ministry of Manpower, Singapore. First, the application of Method A (Effective Stress Method) for designing the diaphragm walls yielded in overestimation of the undrained shear strength. As consequences, it underestimated the diaphragm wall bending moment and wall deflections about 50%. Second, the under design of the waler-strut connection.

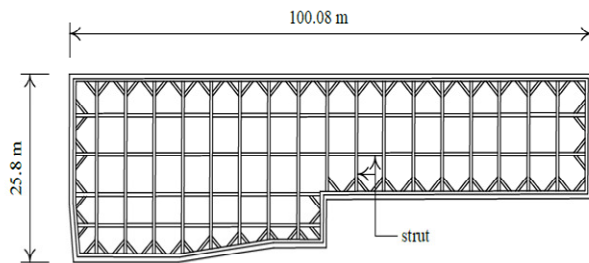
Rebar Broadway excavation is located in Taipei, Taiwan. The shape of the excavation is rectangular (100 m x 26 m), as shown in Fig. 2. The excavation was surrounded by the diaphragm wall with 24 meters in length and 0.7 m in thick. The final excavation depth was 13.45 meter with the spacing of horizontal bracing was varied from 4.1 meters to 5.8 meters. Fig. 3 shows the subsoil profile and construction sequence. The excavation site was located in the backfill zone of a deserted watercourse. The level above the ground surface (GL) of -8.7 meter was the backfill level. The level ranging from GL -10.7 to -44.7 meter was thick, soft, silty clay (CL). The groundwater level was at about GL -2.8 meter. The basal heave failure occurred about 2.5 hours after the final stage of excavation had been completed and the entire internal bracing system collapsed, as shown in Fig 3.

Fig. 2 Excavation plan and arrangement of support system of Taipei Broadway Excavation [6]

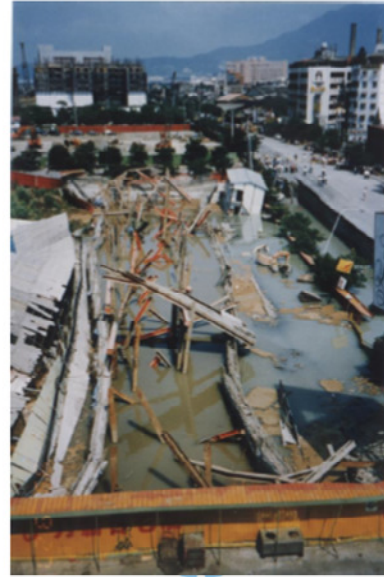
As the result of this failure, the affected area covered about 132 meters in length and 40 meters in width. In this case, due to privacy, no information about the casualty, the total loss, or instrumentation data was released. The possible reasons for this failure were investigated using

finite element method [11]. They concluded that it is most likely that the failure was caused by yielding of struts and diaphragm walls.

Fig. 3 Photo of Rebar Broadway Excavation Failure (Private document)

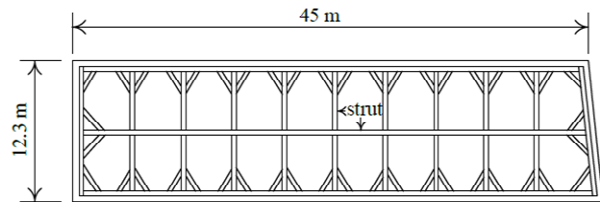
Shipai excavation is also located in Taipei, Taiwan. The shape of excavation is rectangular with 12.3 meters long and 45 meters wide, as shown in Fig 4. The length of diaphragm wall was varying between 13.8 to 17 meter, the average was 15.4 meter and the thickness was only 0.5 meter. The final excavation depth was 9.3 meter with a horizontal bracing structure.

Fig. 4 Excavation plan and arrangement of support system of Shipai Excavation [6]

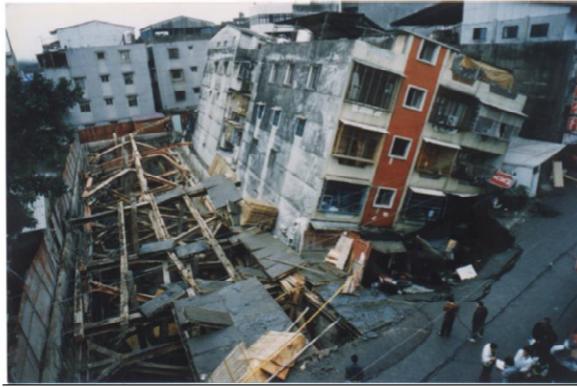
Fig 5 shows the subsoil profile and construction sequence. The level between GL -5.5 and -4.1 meter was a thick layer of silty clay (CL). The groundwater level was at about -1.5 meter. The basal heave failure occurred when this site was excavated down to the final excavation depth as shown in Figure 6. This failure caused the adjacent building tilted toward the excavation area. Similar to the Rebar Broadway excavation, no information about the casualty, the total loss, or instrumentation

data were released. The possible reasons for this failure were also investigated using finite element method [11]. They concluded that it is most likely

that the failure was caused by yielding of the support system, which was indicated by tilting of the adjacent building in the excavation site.

Fig. 5 Photo of Shipai Excavation Failure (Private document)

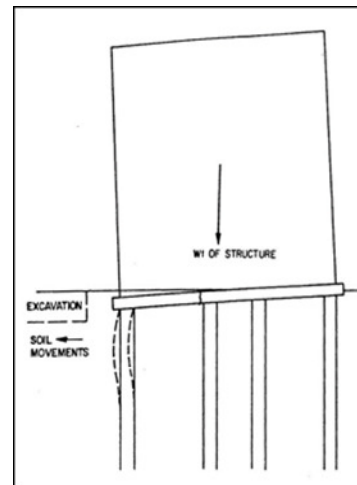
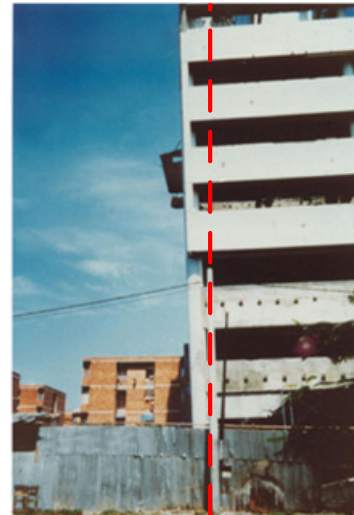
Case A excavation is located in North Jakarta where the soil is predominantly soft clay. Indeed, the characteristic of soft clay in North Jakarta was under consolidating [13]. Similar finding also reported by Cox [14]. The depth of this excavation is relatively shallow, which was only 4 m and the excavation would be utilized for a ground water tank. The excavation was executed using the open cut method, where no retaining wall system was planned. During the excavation, the soil was starting to collapse toward the excavation site. Immediate action was executed by installing bamboo and sheet piles in the surrounding area, and the excavation continued. However, this unplanned temporary retaining wall system could not stop the soil movement. Ten days later, some installed pile foundations which were adjacent to the excavation, prior to construction of pile cap moved 1.0 m laterally. Due to the large movements occurred at the adjacent structures, the excavation was back-filled with uncompact fill material. At this time, the soil at the ground surface started to crack. The distance of soil cracking was around 7 to 8 m or around 2 times of excavation height. On midnight of January 1st to 2nd 1990, the strange sound (similar with a broken sound) was heard three times. At the early morning of January 2nd, 1990, the adjacent office was settled around 140 mm toward the excavation zone and followed by nearby structures, as shown in Fig 6. Some actions

were applied to limit the settlement, such as grouting, but it did not show promising results. Then, in March 1991, the owner of the tilt office decided to demolish the tilt office for safety reason.

In this case, it was obvious that the ignorance in proper design of excavation in soft clay lead to the great financial loss. Key finding on this case is due to the fact that the soil is still underconsolidating and existing excess pore pressures pushed the soils to move. Furthermore, Fig 6 also shows that deep sliding occurred due to unprotected excavation and the piles were not designed to bear this additional movement.

Fig. 6 Illustration and photo of Case A Excavation Failure [15]

2. No matter the scale of excavation geometry, a temporary retaining wall system should be installed to protect soil collapse. Unprotected excavation, though it is shallow, would also generate excessive deformations, as reported in Case A.

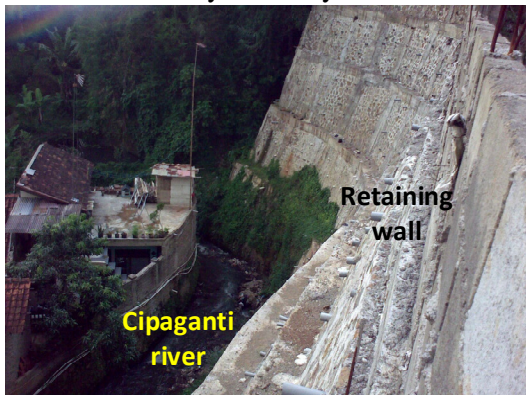
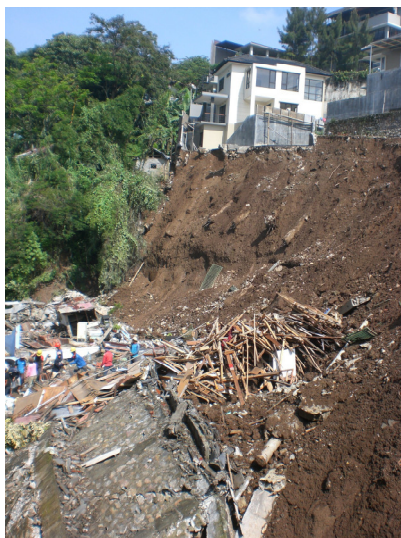
A failure of high retaining wall also recorded in North Bandung in 2004. The height of the retaining wall is about 20 m and the toe is sat on Cipaganti riverbank, as shown in Fig 7. The purpose of this retaining wall is to support the existing slope and

fill material behind the wall. The fill material was used to raise the elevation for a housing development. The fill material was placed colluvium soil. The incident was occurred after a heavy rain the river overflows. It should be noted that flow of Cipaganti river is very swift during rain. It was suspected that the erosion at the toe of retaining wall triggered the failure of the retaining wall.

Fig. 7 Photo of the high retaining wall failure. (a). Before failure, (b). After failure. (Private document)

4. An retaining wall for fill purpose also could failure if not design properly. Colluvial is material that frequently moved during rain and shall not be considered as fill material. The usage of fill material should be carefully decided. More importantly, the retaining wall system should be suitable for the scale of fill material. For the high-retaining wall, the stability at the toe of the retaining wall should be considered by using bored pile, or protected from erosion during flood.

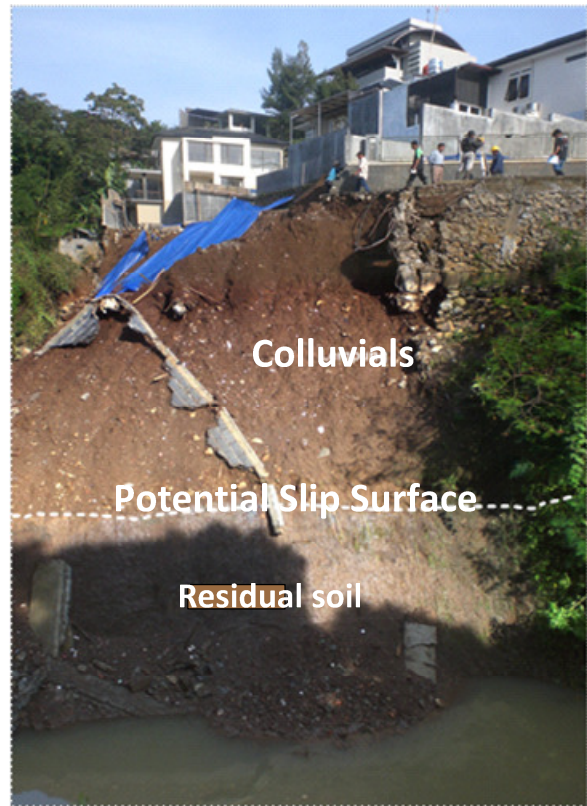
In this incident, at least two houses were buried by the fill material and people inside the houses were injured. Fortunately, no casualties were reported. After the geotechnical investigation, a potential slip surface was found in the interface between colluvials and the residual soil, as illustrated in Fig 8. The characteristic of colluvium material is very porous. As a consequence, water could easily infiltrate in side the fill material. Hence, the usage of colluvium soil as fill material should be treated very carefully.

Fig. 8 Photo of the potential slip surface at the interface of fill and residual soil.

After the incident, the fill materials were excavated and new system of retaining wall was proposed. The proposal used soldier piles which could penetrated into the residual soil, hence the potential slip surface could be restraint.
