INTERNATIONAL SEMINAR ON LIVABLE SPACE

AN OLD BUILDING IN THE COLONIAL HERITAGE STYLE OF 1938 APPEARING TODAY AS A MODERN-STYLE BUILDING

(A Case Study of Architectural Conservation of The Cultural Preservation of The Driekleur Building As A BTPN Bank Office in Bandung)

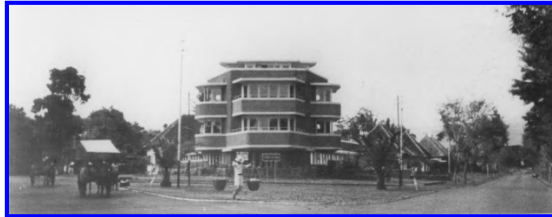
Figure 10: South Elevation by the end of 1930's - Vila de Driekleur (Source : Bandung Heritage)

- Style of modern architecture Nieuw Bouwen on the building envelope, as well suited to the context of place, such as figure 1, 2, 4, 10 and 17 above.
- Recording the history of the above should be presented and easy to see visitors, such as the lobby.

- Style of modern architecture of the building envelope Nieuwe Bouwen with smooth curved pattern in the horizontal plane, matched with the place, figure 1, 2, 4, 10, 17.
- The unity of the windows on the building envelope, figure 1, 10, 16 and 18.
- The pattern of the stone material attached at the bottom and smooth painted stucco on the top of the building envelope, such as figure 1, 8 above.

Political Value, namely the expression of the attitude of the Dutch colonial modernity that appear through the Nieuwe Bouwen modern architectural styles, such as figure 1, 2, 4, 10, 17.

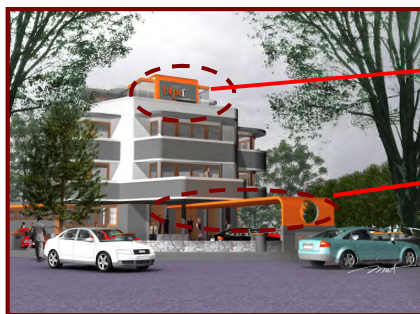
Figure 17: Corner Elevation
(Source: Bandung Heritage)

Engineering Value, construction technology related to the width of the horizontal plane smooth continuous curved shape, which is quite difficult to make, figure 1, 17 and 18 above. Also lighting and natural ventilation systems are quite good, the images 17 and 18.

- Style of modern architecture in the form of Nieuwe Bouwen sheath fields horizontally curved plain, which fits with its place on the corner of the street, like a picture 17.
- Large glass windows, eaves and wide corridor along the sheath to make a broad view and protected from sunlight and glare, as well as lack of access to the building envelope maintenance such as images 17 and 18 above.

Landmark Value, related to its position on the corner of Dago-Sultan Agung streets and shape of the building envelope area overlooking the corner so that it becomes a sign of / reference to the environment around the corner Dago-Sultan Agung, like figure 2 and 17.
