An assessment of Cikangkareng rockfall due to the Tasikmalaya earthquake on September 2, 2009

Lestari Sri Anastasia^{1,*} and Lim Aswin¹

¹Civil Engineering Department, Parahyangan Catholic University, Jl. Ciumbuleuit 94, Bandung, Indonesia

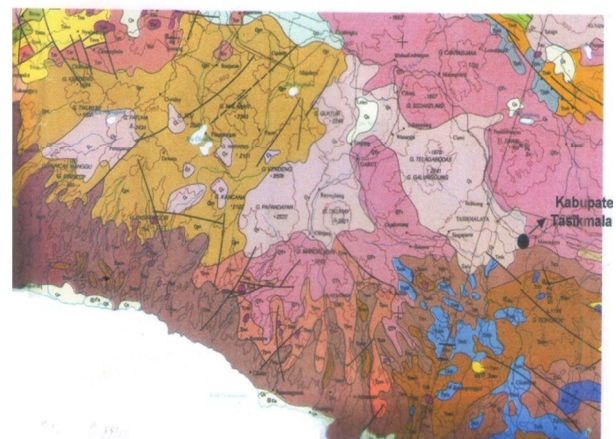
Fig. 4. Geology of West Java

Based on the geological map of West Java, as shown in Fig. 4, the southern part of West Java is dominated by Holocene volcano rock (Qv). This rock is formed from an active volcanic sediment consisting of lava, breccias, tuff, loose lava sediment which generally takes the form of andesite and basalt. The sources of Qv are Galunggung mountain and Talagabodas mountain.

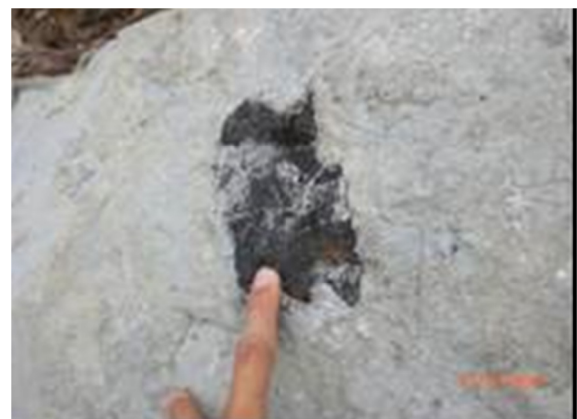
Fig. 15. Wood fossil (sedimentary rock)

The debris rockfall due to the chemical weathering process (Figs. 14 and 15). The chemical test shows that the composition of the chemical is SiO_2 ($\pm 59\%$), and Al_2O_3 ($\pm 14\%$) Fe_2O_3 (6 -8%), CaO ($\pm 4\%$), LOI ($\pm 6\%$).

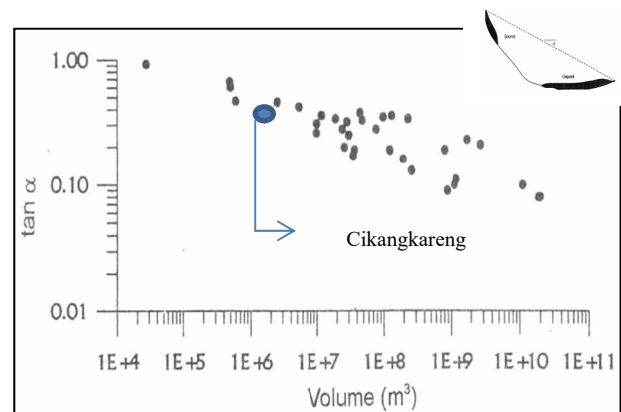
Fig. 20. The relationship between Volume debris and alpha (1)

The volume of debris rockfall at Cikangkareng and the alpha is close to the graph which correlated the alpha and debris volume (see. Figs. 20 and 21)

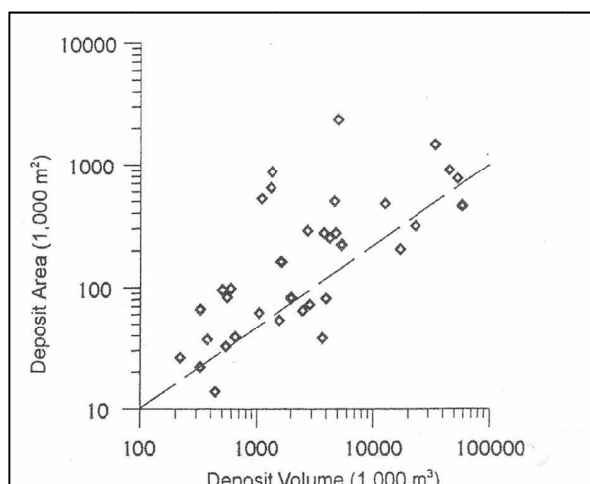
Fig. 22. Landslides & Other Mass Movement

Fig. 22. shows that the volume of debris rockfall at Cikangkareng was included on a plot of the deposit area against volume for 35 rock avalanches from North America and Europe. The dashed line has a slope of 2/3. [12]
