**EFFECTS OF GRADUALLY CONSTRUCTED  
LEVEES ON THE FLOOD CHARACTERISTICS IN  
MAEN VILLAGE, NORTH SULAWESI, INDONESIA**

**JASON EDGARDO TANDRA  
NPM: 6101901101**

**PARAHYANGAN CATHOLIC UNIVERSITY  
FACULTY OF ENGINEERING  
CIVIL ENGINEERING DEPARTMENT**

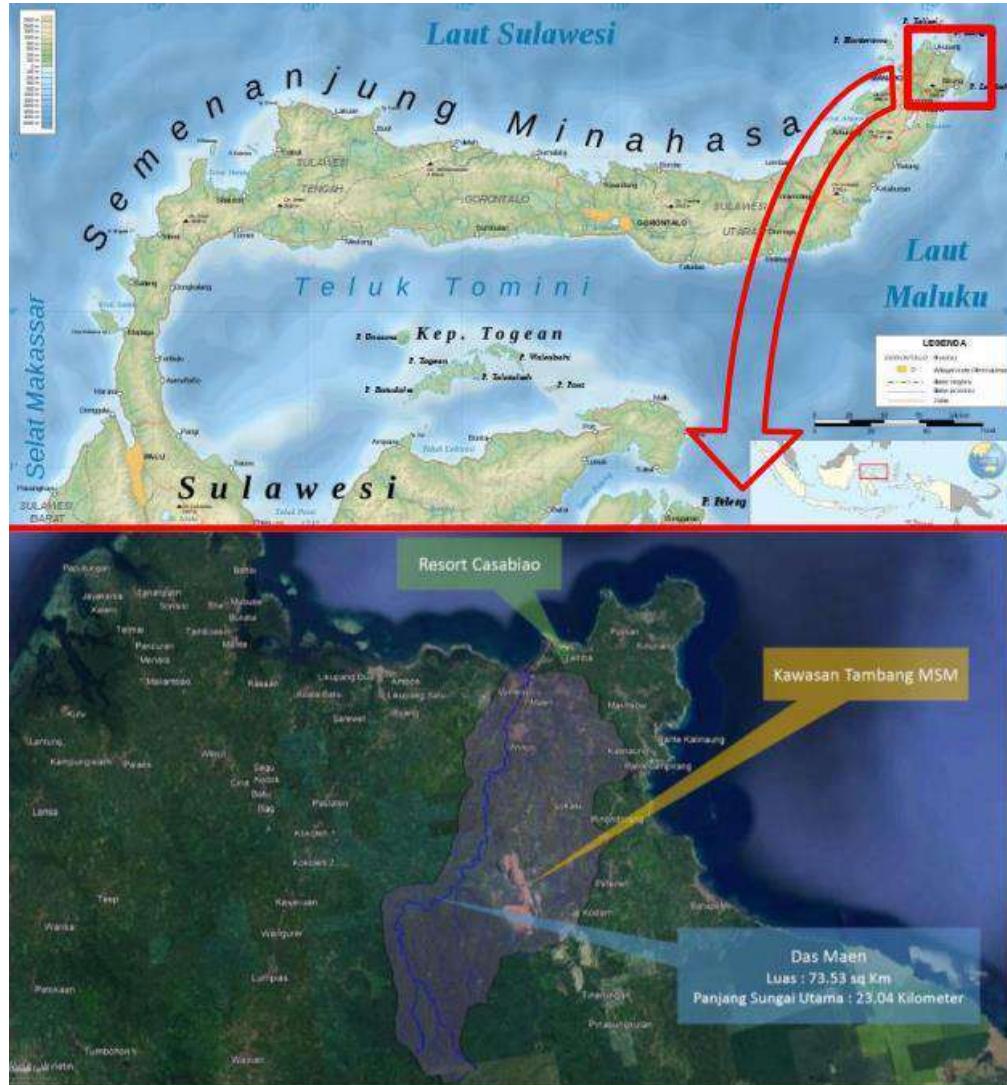
**Figure 1.1** Maen River Basin (PT Aditya Engineering Consultant, 2021)

As shown in **Figure 1.1**, Maen village is located in the northern part of the Maen River Basin with an area of 73.53 km<sup>2</sup>. The length of the main river is approximately 23 km. In addition, there is also a small Maen River on the eastern side of the main Maen River. For several cases, the levee construction on rivers may become more complicated due to several reasons, for example, if it is not feasible to build the levees simultaneously along the rivers because of budget limitations. Hence, knowing the priority of the river parts on which the levees are constructed is of importance and must be thoroughly investigated by the engineers and the related stakeholders.

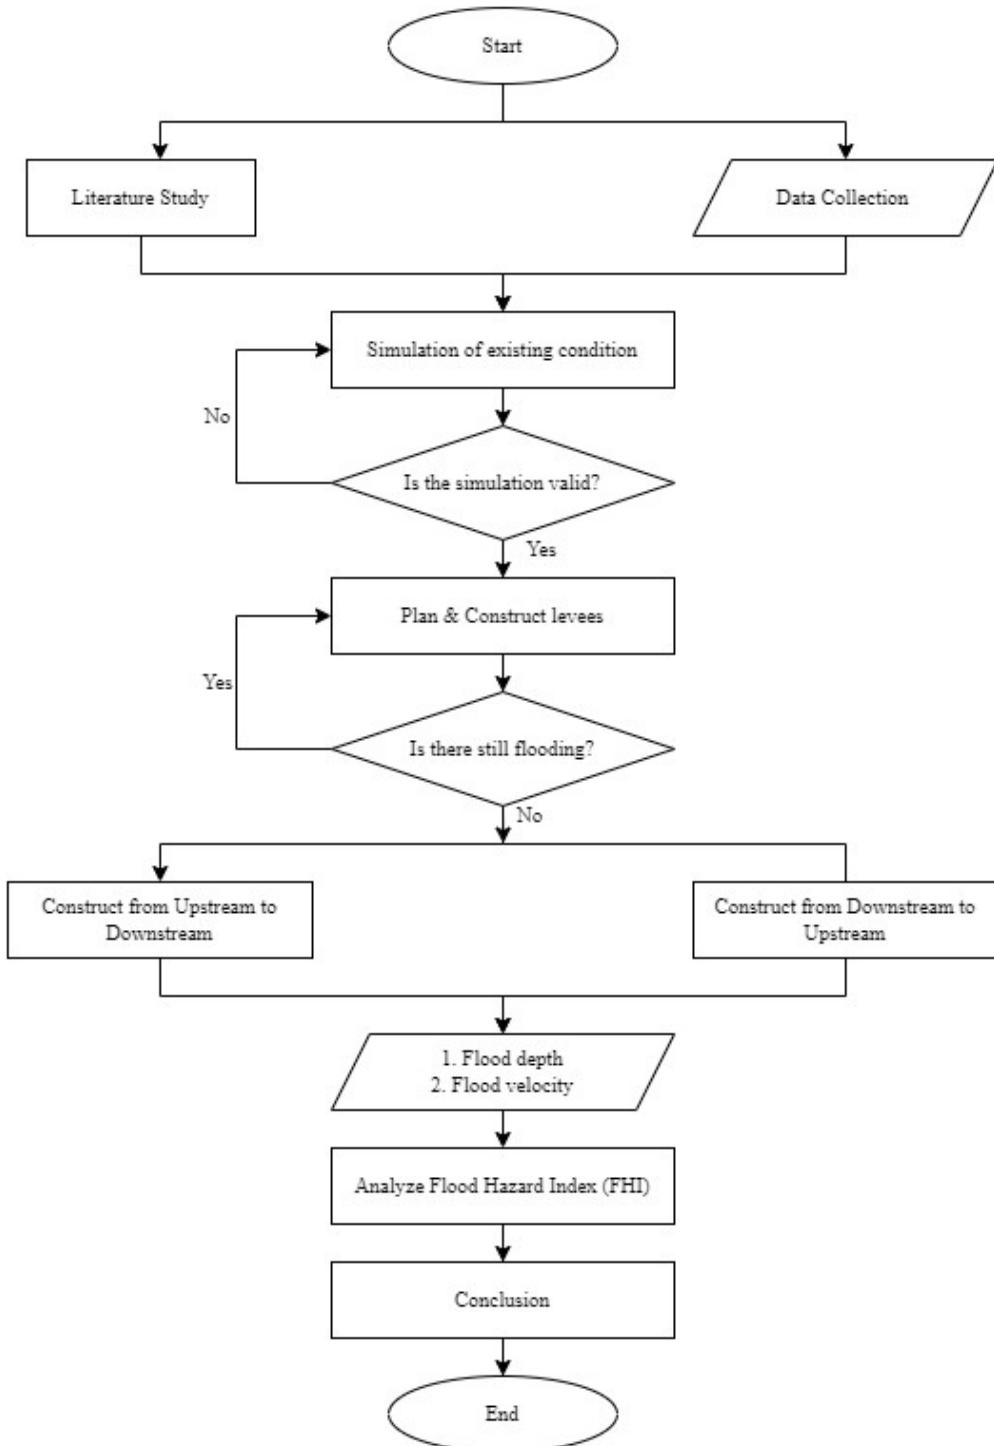
**Figure 1.2** Flow Chart

The research methodology is also shown in **Figure 1.2** below.
